# TECHNICAL BULLETIN

## FORD FALCON BA & BF

### PAINT DELAMINATING FAULT

JUNE 2011

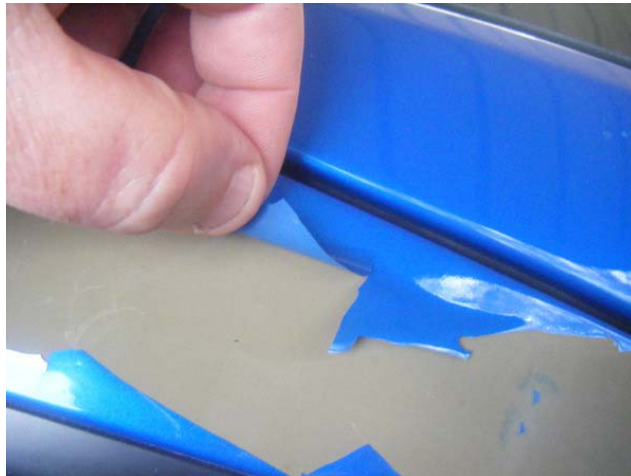
- Ford Australia has noted that a manufacturing fault during the application of electro coat primers has resulted in the paint top coat film delaminating from the primer surface
- The available information indicates that the paint quality issue affects models ranging from BA to BF series, body variances from sedans, commercials and Fairmont equipment level
- Ford Australia has been managing these paint warranty claims throughout its Ford dealerships. Ford has also appointed the AARN body repairer network to carry out the re painting of warranty claims

- Information sourced indicates that paint delimitation is not contained within a specific area or panel of the vehicles
- Motor vehicle assessors should be aware of this paint warranty issue when conducting Quality Assurance inspection

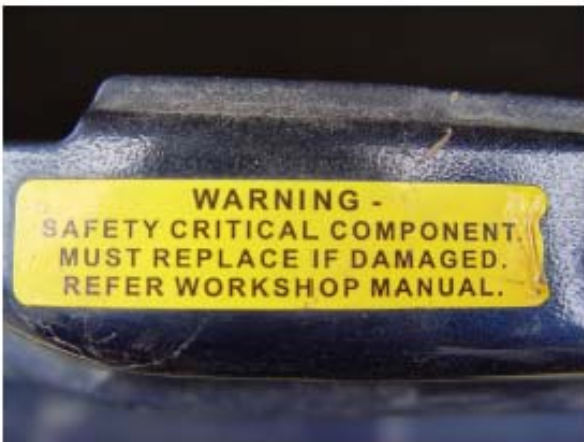
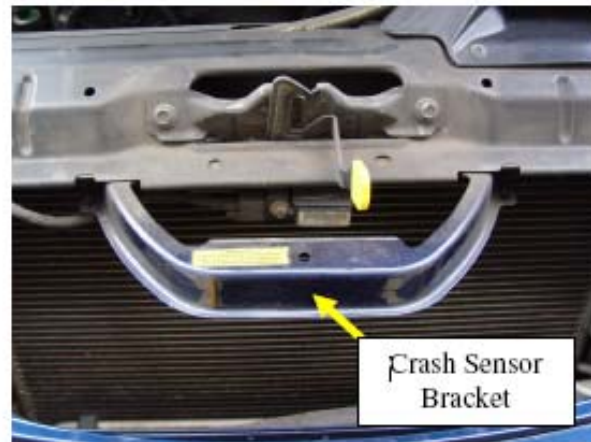
The radiator support top lock panel has been designed and fitted with a crash sensor bracket. This bracket is positioned at the centre of the top lock panel and Ford refers to it as a “towel rail panel”. The Falcon body repair manual indicates that the crash sensor bracket *must not be straightened or panel beaten* after it has been involved in a frontal collision and has sustained any form of impact damage.

This bracket is critical for the correct function of the crash severity sensor, which is positioned behind the crash sensor bracket. The crash severity sensor performance is critical to the correct deployment of the front airbags in a frontal collision.

The bracket is listed as an individual part, (Part No. BA14B058A, List Price \$28.05 + GST) or it is also available with the complete radiator support panel assembly (Part No BAFF10922A, List Price \$249.00 + GST).

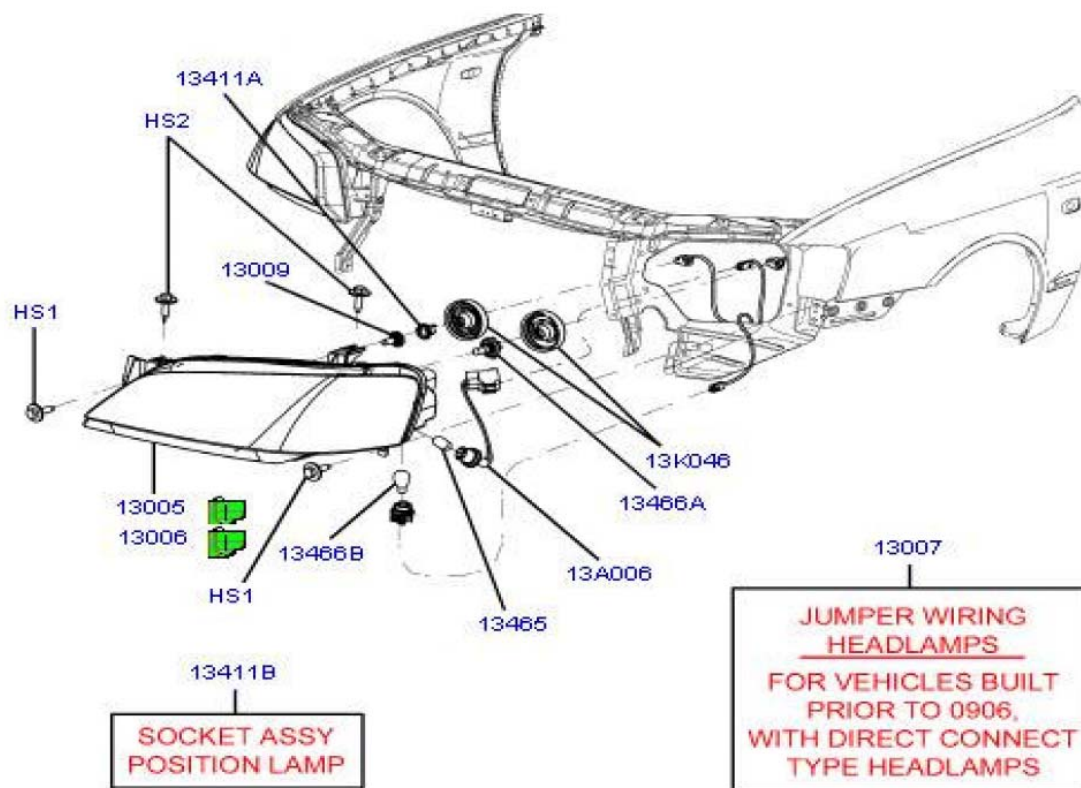
The diagram below shows the parts catalogue diagram describing the bridging wiring connector. The wiring connectors enable the existing wiring in vehicle to match the new headlamp assembly socket.

The part number for the wiring connector is BAF13007A and the list price is \$13.80 per headlamp.

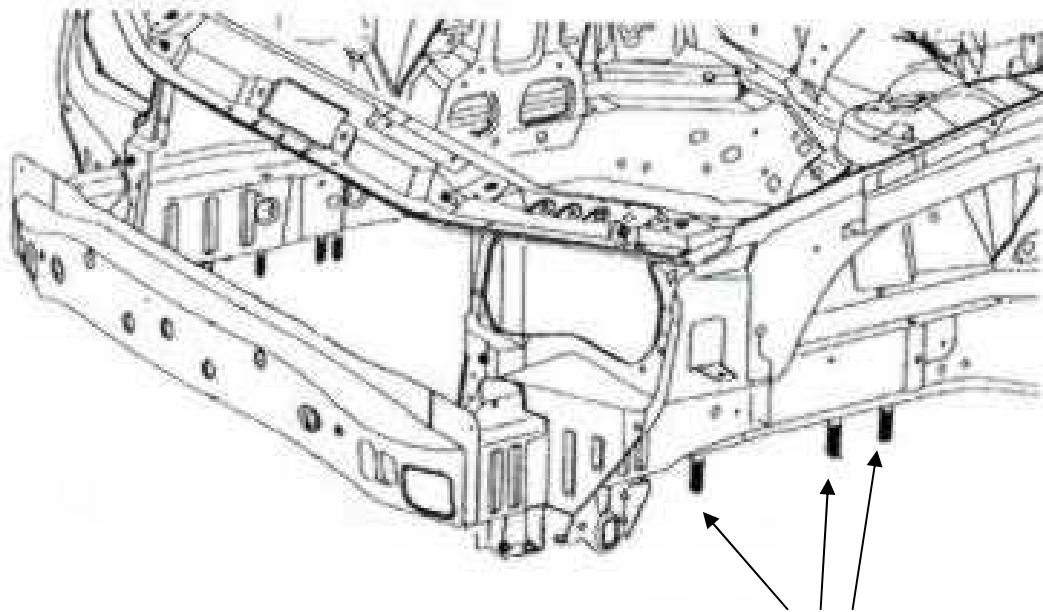
Cross member bolts.

These bolts were made available for Falcon following a request from the Research Centre. They can be bent in front impacts due to their considerable length which is a requirement of production during assembly of the vehicle.

Investigative work by the Research Centre revealed that the Falcon cross member bolts are interchangeable with Territory. The part number for the bolt is W706568S300 and the list price \$3.40. The nut is also available, part number W705291S309, list price \$2.60.

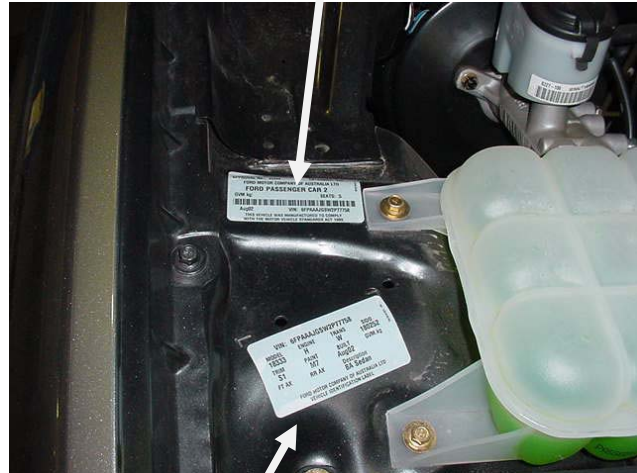
Compliance label

Many assessors will be aware of the build and compliance labels located on the right hand front skirt suspension tower on BA series Fords. Numerous enquiries have been directed to the Research Centre regarding their replacement in the event of crash repairs to this area of the vehicle.

It is important to note that the labels self – void when removed and therefore are unable to be reused.

Assessors should advise repairers of the problem, suggesting not to remove the labels unless necessary and make all efforts possible to repair the car without replacing the RH suspension tower. Consideration should be given to potential disputes arising over loss of vehicle value if the car is returned to the owner without the compliance label fitted. If customers are concerned about panels being replaced, they should be advised of Ford's policy and reassured that the labels are not the vehicle's identifiers and are not required for registration.

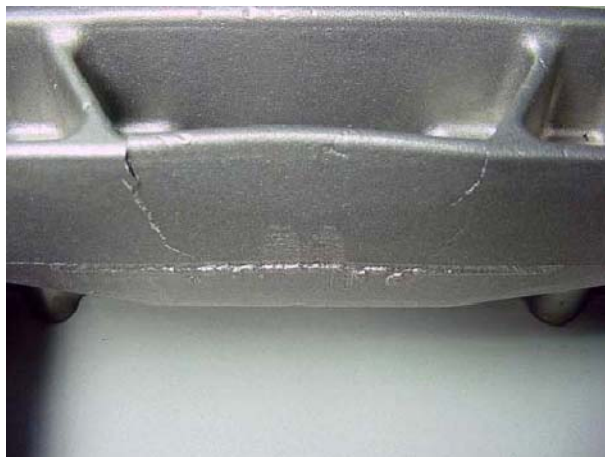
Gearbox cross member

As a result of 2 Low Speed Crash Tests and a transmission-locking test on Ford Falcon BA with automatic transmission, the IAG Research Centre has vital information regarding damage to the rear gearbox cross member.

In both Low Speed Crash Tests, which are equivalent to the common nose to tail collision at 25 km/h and one bump test, damage occurred to some or all of the following components.

It seems that soft engine mountings allow increased movement of the engine during impact causing the failure of the above-mentioned components.

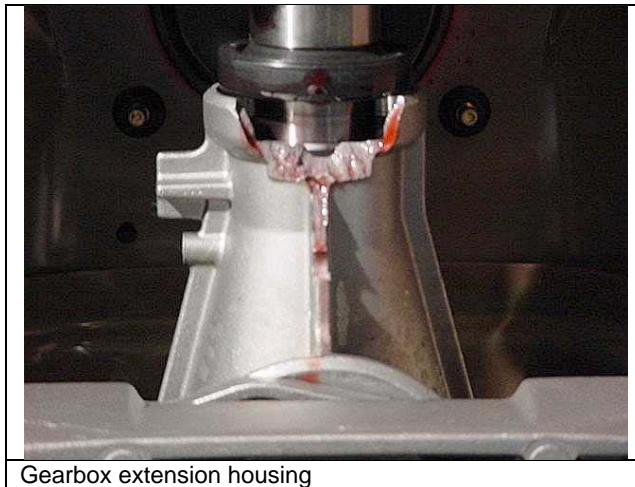
Gearbox extension housing

In one case damage occurred to the transmission extension housing.

The effected area is at the rear of the housing adjacent to the tail shaft.

In instances where the gearbox extension housing has broken, the tail shaft will need to be removed and rebalanced as part of the installation procedure.

Therefore it is advised that damage to this extent should be sublet to a Ford dealer.

Ford has advised that an approximate sublet allowance of 2.50 hours should be considered for this operation. When the damage is more moderate, i.e. the gearbox extension housing is intact, smash repairers should be capable of performing the work themselves. The table below gives list prices and recommended remove and replace allowances for the components Gearbox Extension Housing affected in those instances.
