# TECHNICAL BULLETIN

## FORD FALCON BA & BF

### PAINT DELAMINATING FAULT

JUNE 2011

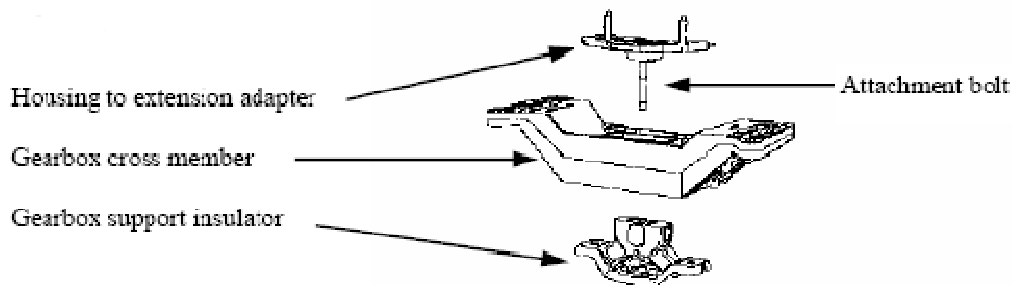
In both Low Speed Crash Tests, which are equivalent to the common nose to tail collision at 25 km/h and one bump test, damage occurred to some or all of the following components.

\*NOTE; The attachment bolt can only be purchased with the housing to extension adapter.

It seems that soft engine mountings allow increased movement of the engine during impact causing the failure of the above-mentioned components.

In one case damage occurred to the transmission extension housing.

In instances where the gearbox extension housing has broken, the tail shaft will need to be removed and rebalanced as part of the installation procedure.

Therefore it is advised that damage to this extent should be sublet to a Ford dealer.

Ford has advised that an approximate sublet allowance of 2.50 hours should be considered for this operation. When the damage is more moderate, i.e. the gearbox extension housing is intact, smash repairers should be capable of performing the work themselves. The table below gives list prices and recommended remove and replace allowances for the components Gearbox Extension Housing affected in those instances.
